# **CHALLENGES AND REMEDIAL MEASURES OF WELL DRILLING SITE DEVELOPMENT IN BANGLADESH**

**MD. SHAHINUR RAHMAN FARAZI**

MASTER OF ENGINEERING IN PETROLEUM ENGINEERING

OCTOBER 2013.

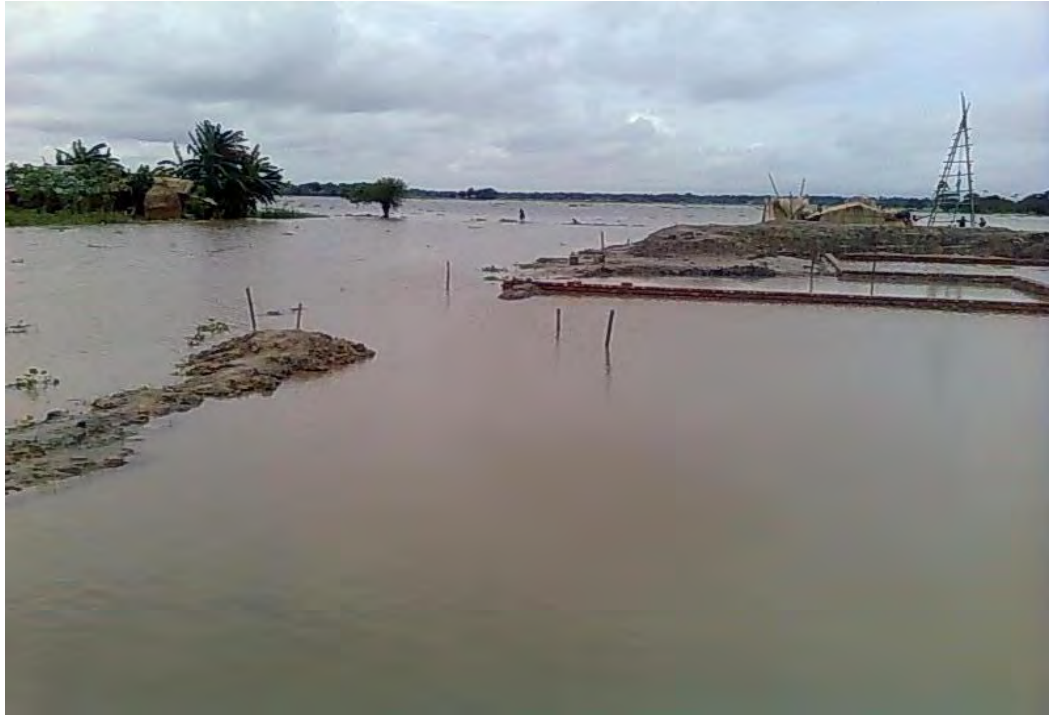
to some areas, disrupted the roadway and delayed the works for about 2-3 months. Figure 4.3 shows the stagnant floodwater in the project site and approach road in the year 2011.

The filled land of the site was mostly washed out when the floodwater receded. Foundation, prepared for machinery at the backside of the site, was damaged. The bank of mud pit and the machinery foundation were then repaired by palisading and earth work again. It caused a serious loss to the project. The incident could be avoided or mitigated by:

Figure 4.3: Flood water enters the project area and disrupting the communication system in year 2011 at Sunetra.

- Developing the project area by considering the highest flood level based on data of about 100 years or more from official sources, such as Water Development board,

Board, LGED or Weather office, instead of local people's testimony.

- Constructing a retaining wall around the project area to protect the site from floodwater. (Same type of retaining wall has constructed to well site at Mobarakpur and semutang gas fields of Bangladesh.
- Providing compaction of the filled soil by means of soil compactor or grader etc to achieve 100% dry density. Otherwise, the loose soil may be washed out or settled down easily. The use of cohesive soil instead of sandy soil may be helpful to mitigate the problem also.

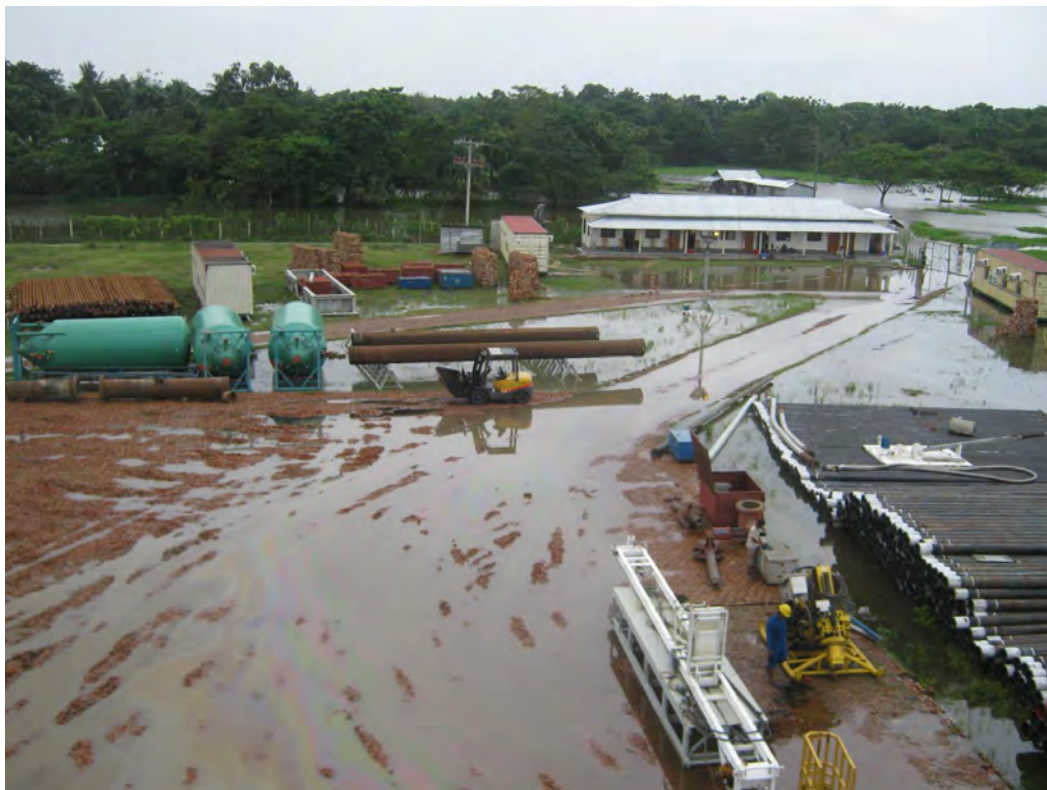
Figure 4.4: Flood water disrupting the drilling in the year 2012 at Sunetra.

We did not have taken any one of the above precaution. Initially a dam was constructed across the path of floodwater. Laborers stopped working when the water further increased. As a result, the valuable equipments, VFD house, living caravans etc needed to rose by 4 ft. providing wooden block, brick block etc urgently. These involved additional cost, time and extra efforts. If the measures were not taken urgently, the damage to valuable equipments would be serious, and could jeopardize the entire project.

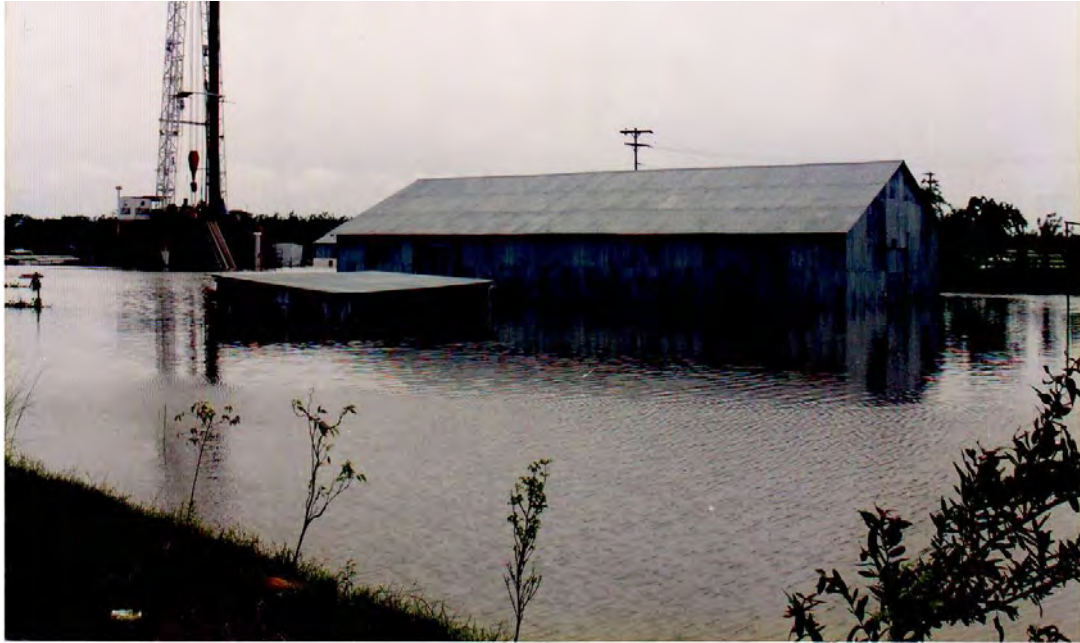
There was nothing to do but to wait for dewatering the area. The sudden flood damaged the mud pump, water pump, generator, living caravans, storage godowns and other

infrastructures. To repair and maintenance of these, an additional cost of about 200 lakh was incurred.

Figure 4.9: Inundation of whole drilling area under flood water at Srikail 1.

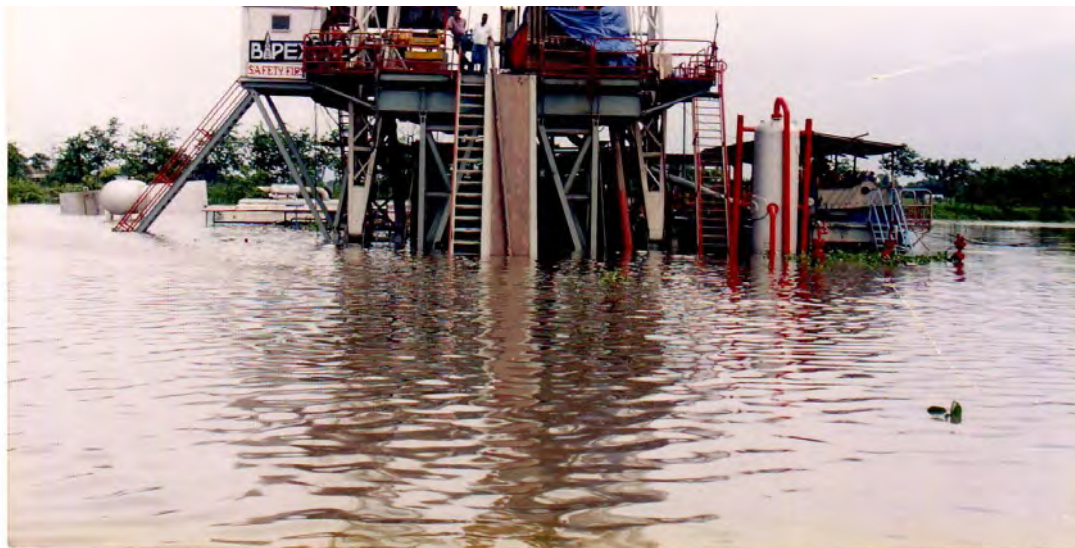
Figure 4.10: Inundation of rig, generator and other infrastructures under flood water at Srikail 1.

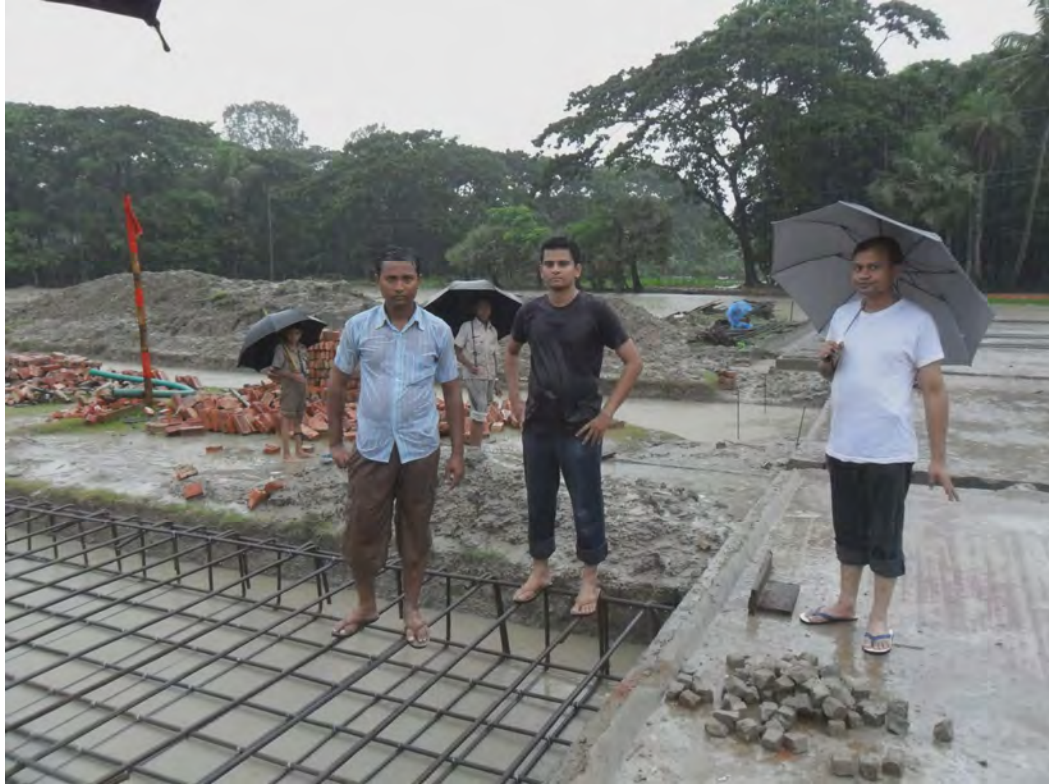
- **Excessive rain and flood:** The project area was free from flood. Greater Noakhali is a rain prone area. The average precipitation occurs 3302 mm annually, whereas, the yearly average rainfall in Bangladesh is 2666 mm. The development works started during rainy season. As a result, the construction works delayed and the on going works remain suspended. It causes time and cost overrun to the project. At the time of casting the rig foundation, it was raining mercilessly and we had to use tarpaulin. The construction works continued in rain at sundalpur shown in Figure 4.15 and Figure 4.16.

Figure 4.15: Rig foundation construction progresses in rain at Sundalpur 1 well drilling project.

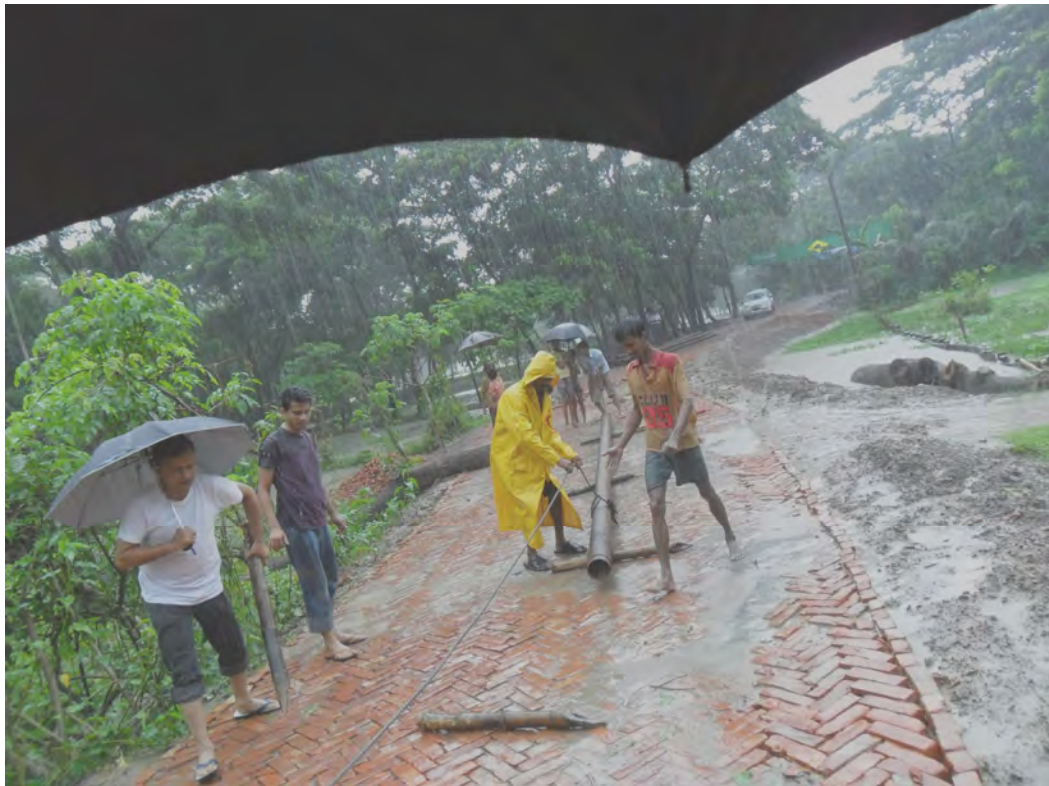
Figure 4.16: Construction works in rain at Sundalpur 1 well drilling project.

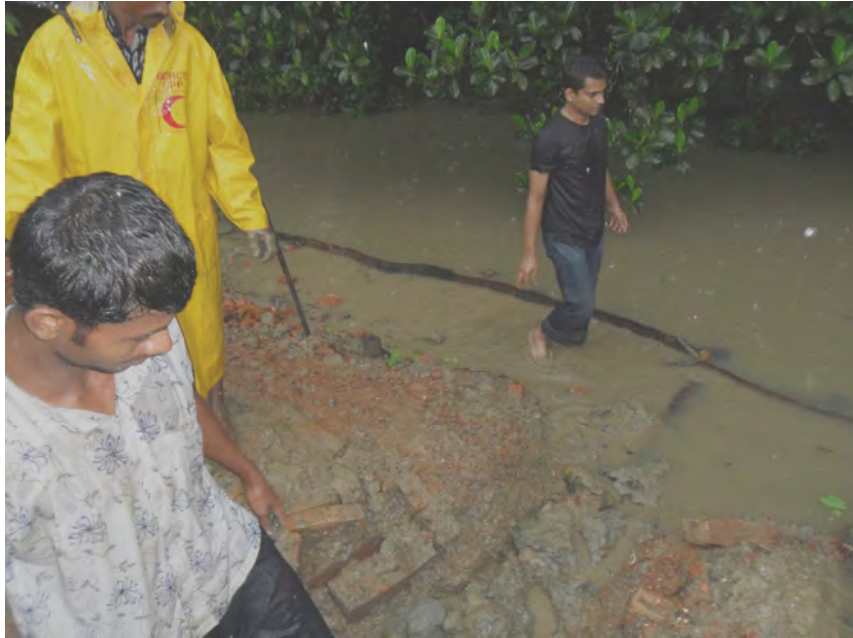
In summary, it can be said that the main problem was untimely working schedule of the project. Improper drainage, proximity to habituated locality, high price of land, soil and

Figure 4.17: Artificial canal/ drain preparation and maintenance to drain out the entrapped water at Sundalpur 1 well drilling project.

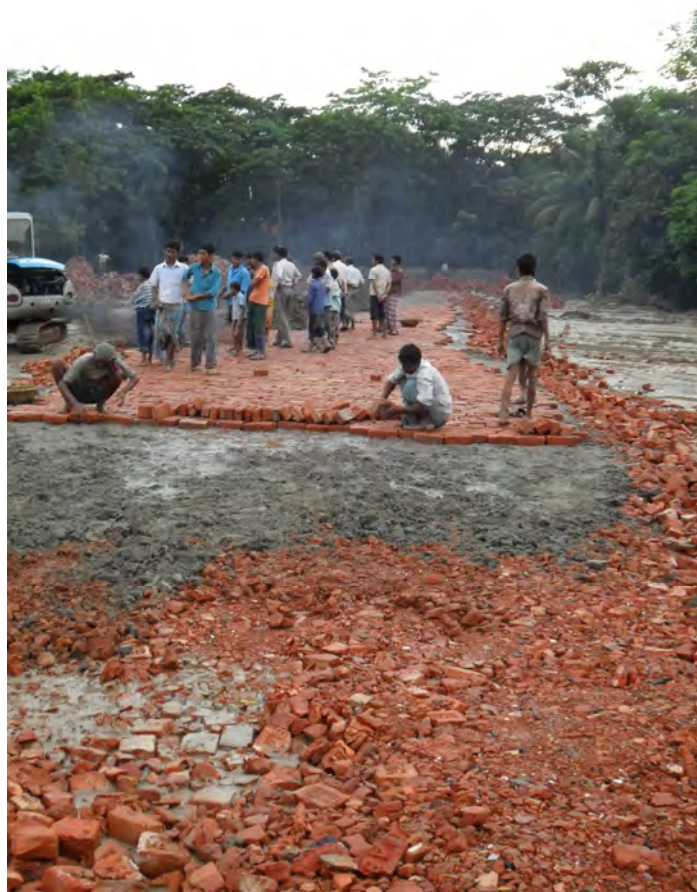
Figure 4.18: Providing brick bats beneath the brick soling of drilling site road.
