# **Morphological Changes in Teesta River Basin: Impact and Adaptation Strategies in the Northern Bangladesh**

**PhD Dissertation**

**Department of Geography and Environmental Studies**

**University of Rajshahi, Rajshahi-6205, Bangladesh**

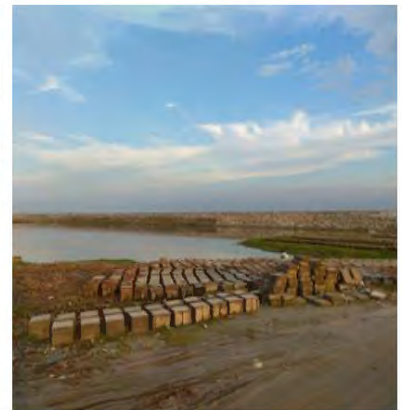
5. c) Teesta river revetment
