**EROSION OF LEFT BANK OF THE PADMA RIVER AT MAWA-  
DIGHIRPER REACH AND ITS SOCIO-ECONOMIC IMPACT**

**A thesis by  
Mohammad Arifur Rahman**

**In partial fulfillment of the requirement for the  
Master of Science in Water Resources Development**

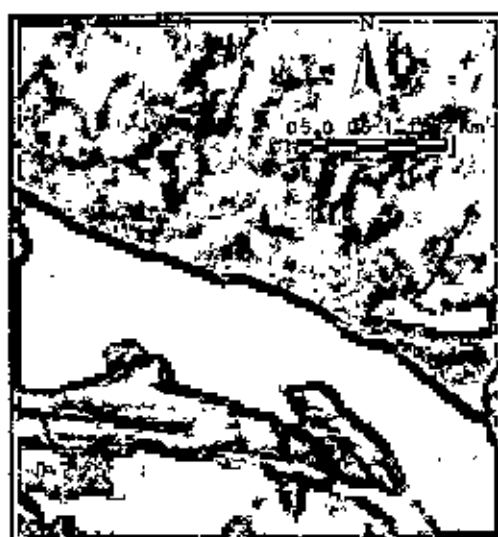
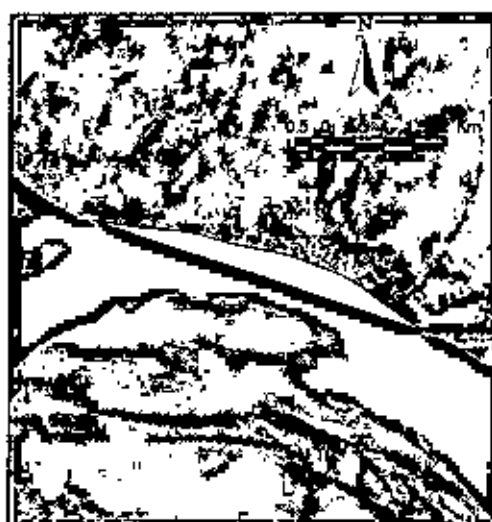
**Figure 4.12: Imageries of active reach from 2003 to 2006.**

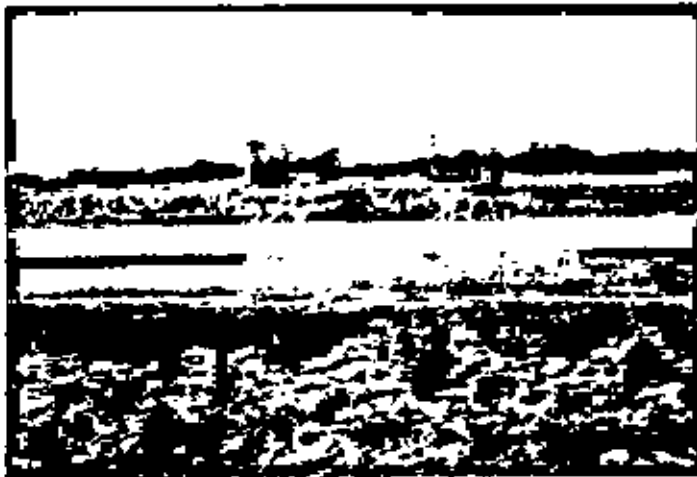
**Figure B4: New Char  
formed reverse of the bank  
of Hasail-Banari and  
Dighirper reach.**

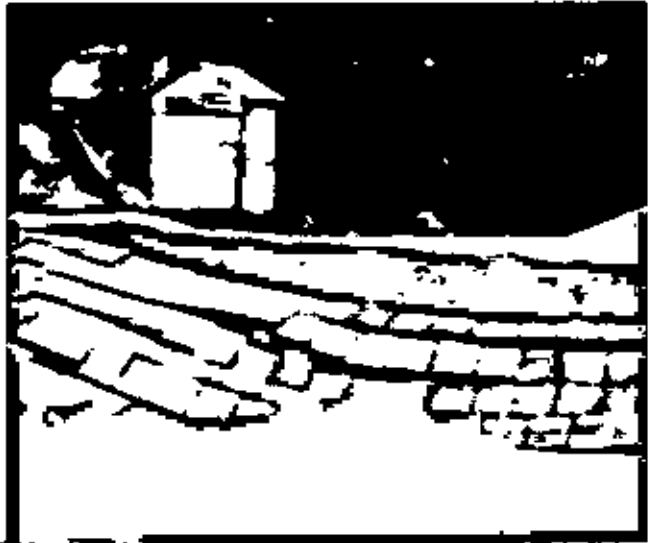
**Figure B6: Erosion protected embankment in Hasall-Banari reach is now disappearing.**

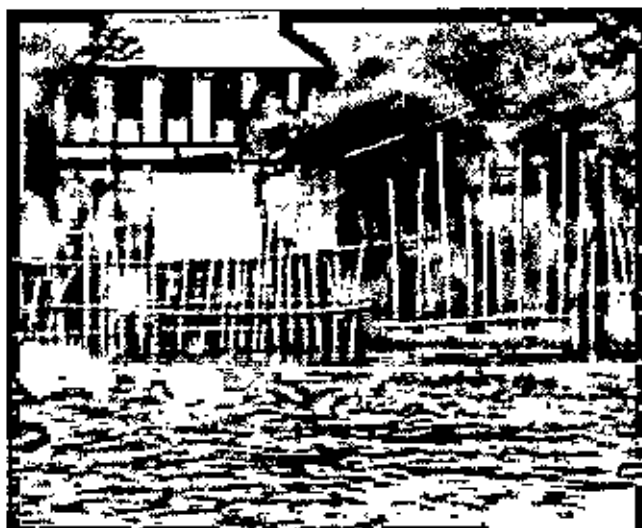
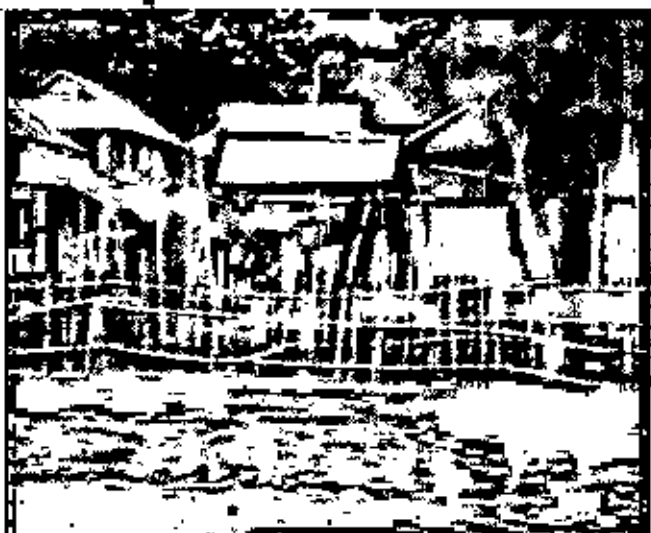
Figure B11: Rich people protect their house from bank erosion by  
bamboo fence.
